Facility: Van Waters and Rogers, Portland

ID No: ORD 00922 7398 **Date of Inspection:** September 10, 1990
Date of Report: January 11, 1991

Report prepared by: Deborah Robinson
RCRA Compliance Section
EPA Region 10

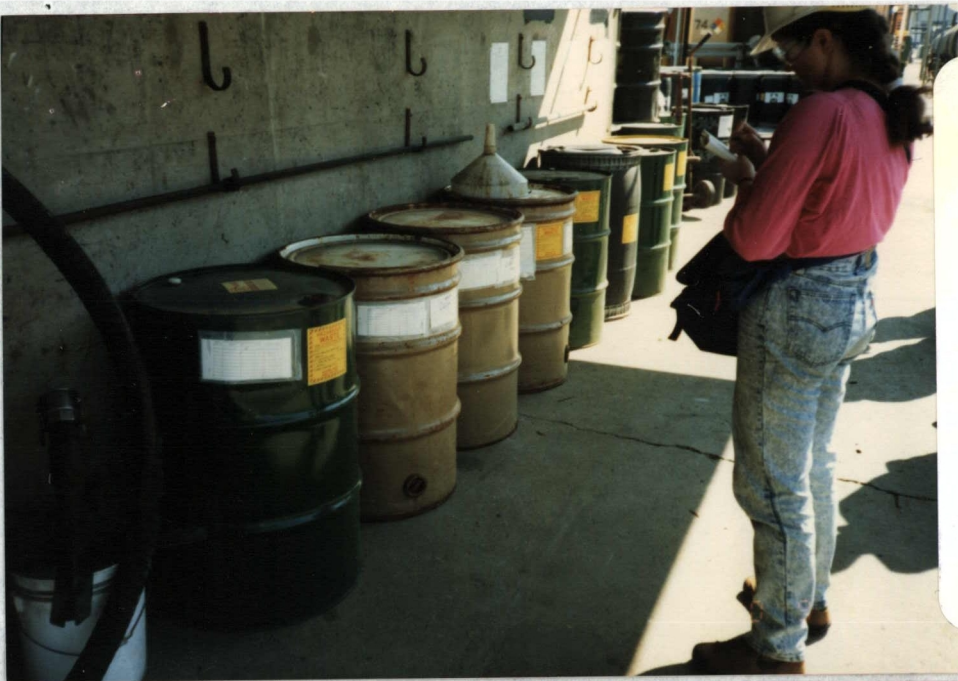
Photograph #1:

On the loading dock I observed eight drums used by the facility to contain hazardous waste. Photographs numbered 1, 2, 3 and 4 (see Appendix 7) show the containers on the loading dock. The loading dock is cement, and is covered.

1. Three instances of inappropriate use of the satellite accumulation rule (40 C.F.R. § 262.34(c)):
 - a) Wastes generated at the ground water monitoring wells are stored in the satellite accumulation area for longer than 90 days. This is not at the point of generation and not under control of the operator of the process generating the waste. Since there is no appropriate place to store hazardous waste next to each monitoring well, the wastes generated at the wells should be placed in the generator accumulation area.

- b) A total of four 55-gallon drums of waste generated from containers returned by VWR's customers were present; two of the drums were labeled with the same waste code (D001). The satellite accumulation rule only allows accumulation of up to 55 gallons of hazardous waste in a satellite accumulation area. In order to use the loading dock as a satellite accumulation area, the facility should assure that no more than 55 gallons of waste are accumulated on the dock under 262.34(c).

- c) Because hazardous waste accumulated at the loading dock is generated intermittently, it is not under constant surveillance by the people collecting hazardous waste in drums. The satellite accumulation rule requires that the area be under control of the operator of the process generating the waste. In addition, the March 1990 Region 10 satellite accumulation policy memo states that drums should be within sight of the operator of the process or locked. Ideally, the facility should use bung locks or some other means to prevent people from accessing the drums in the absence of the operator of the process generating the waste.

West side loading dock; generator accumulation area. Eight (55-gallon) containers of hazardous waste stored. Four containers of solids from on-site corrective action clean-up work. Four containers of liquids from customer containers returned for refill. Van Water & Rogers reps claim area to be satellite accumulation storage.

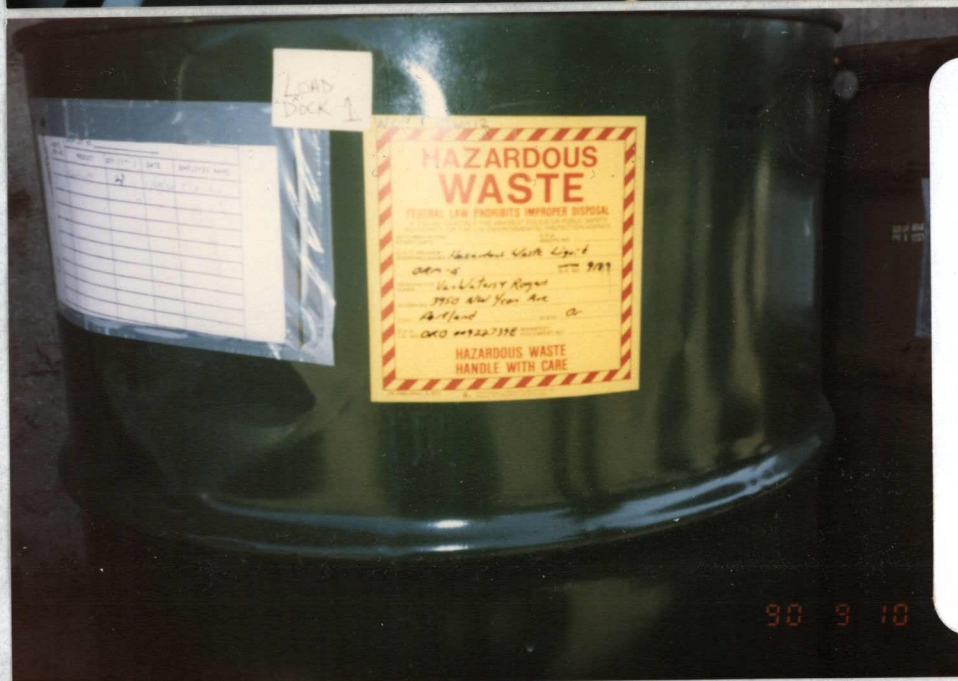
Photograph #2:

I observed one green drum labelled SMW-12. A log sheet was taped to the drum (see photographs 2 and 3, Appendix 7). According to facility representatives, the log sheet shows each date waste is added to a drum. The initial date on the log was 5/24/90.

Note: Green drum in foreground (in photograph #1) marked with the date accumulation began 5/24/90. This was contaminated groundwater removed from SMW-2.

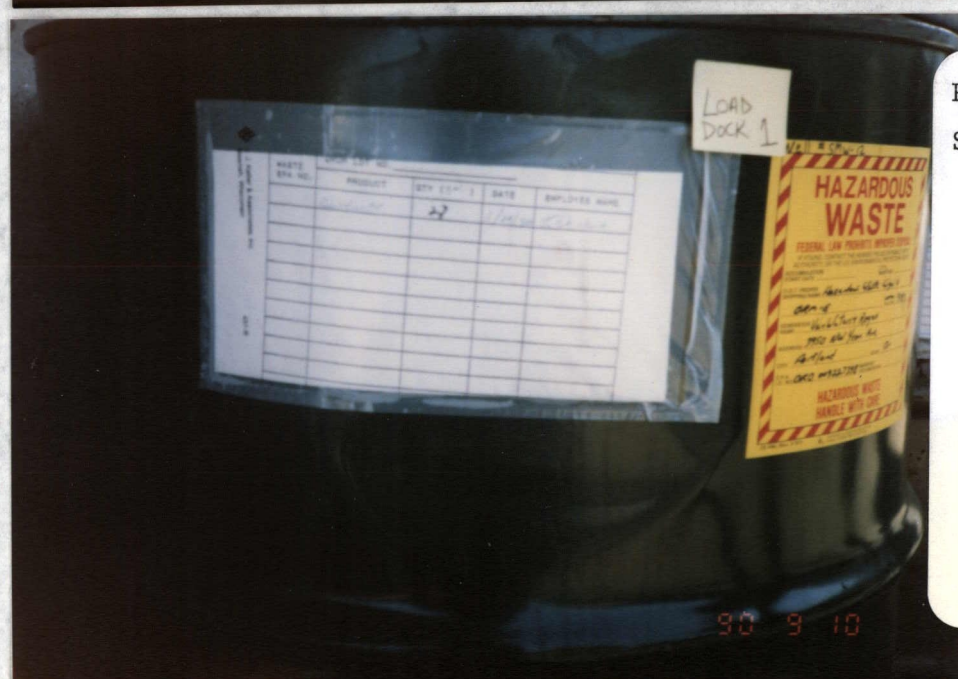
Photograph #3:

Shows accumulation date of 5/24/90.

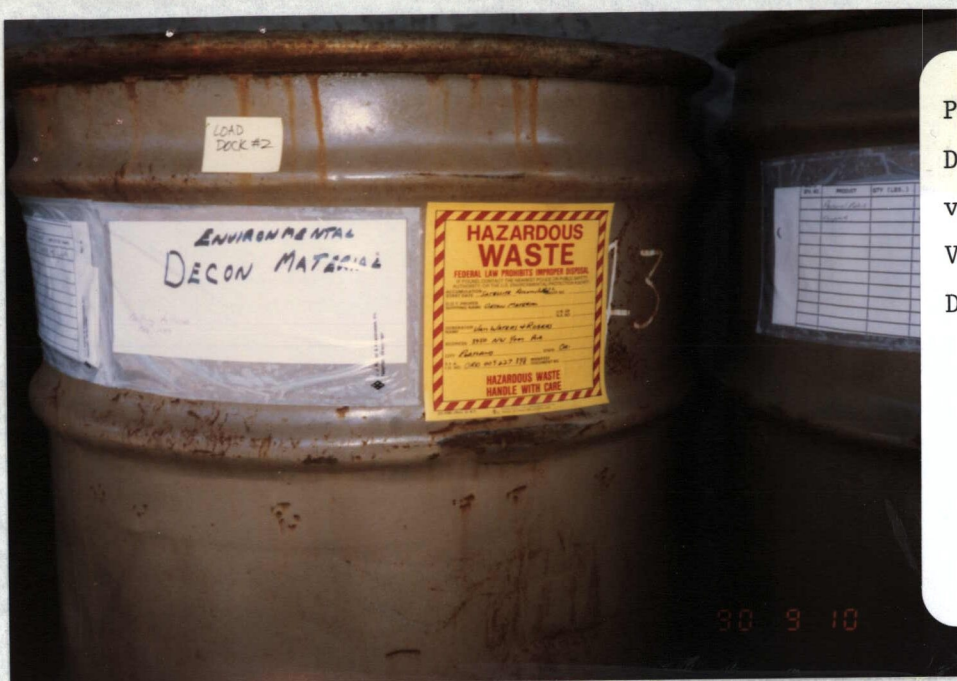
Photograph #4:

I observed three brown drums labelled as decontamination material. There were not dates on the hazardous waste label; however the log sheets on each drum had the date 2/26/89. George Sylvester stated that the drums are used in decontamination lines. He said the drums are moved to a well, waste is deposited into the drum, and then the drums are returned to the loading dock. George Sylvester stated that these drums are used as satellite accumulation drums.

Decon material generated at various locations around the Van Water & Rogers' property. Date accumulation began 2/26/80.

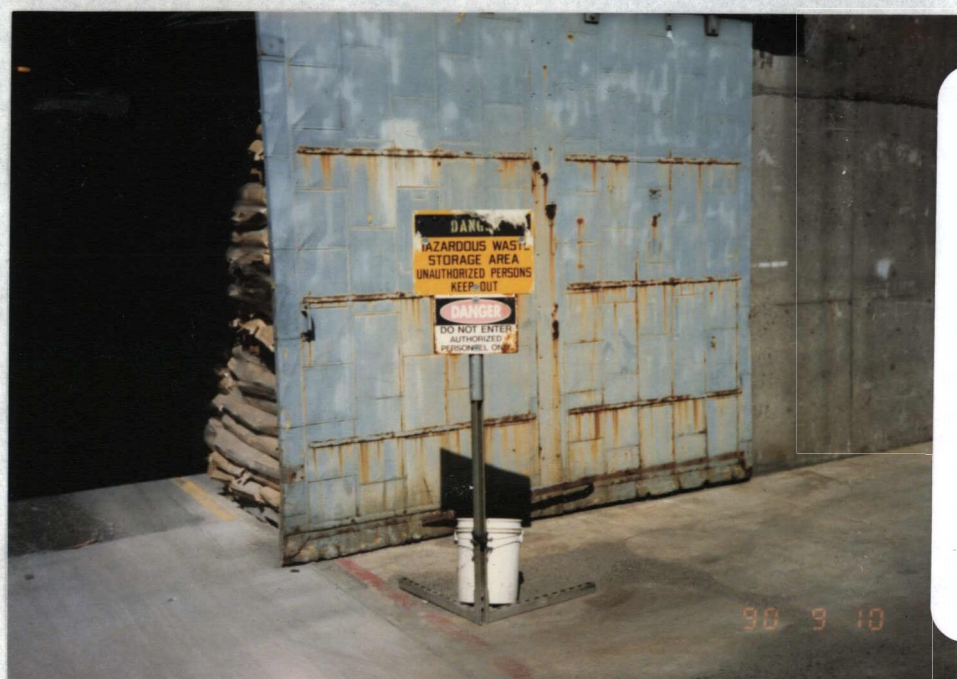
Photograph #5:

The hazardous waste accumulation area (photographs 5 and 6, Appendix 7) is concrete and is not covered. The area is not fenced and has no secondary containment. There was no hazardous waste in storage in this area during our inspection. The area is immediately adjacent to a door into the warehouse.

Sign marking "90 Day" generator storage area.

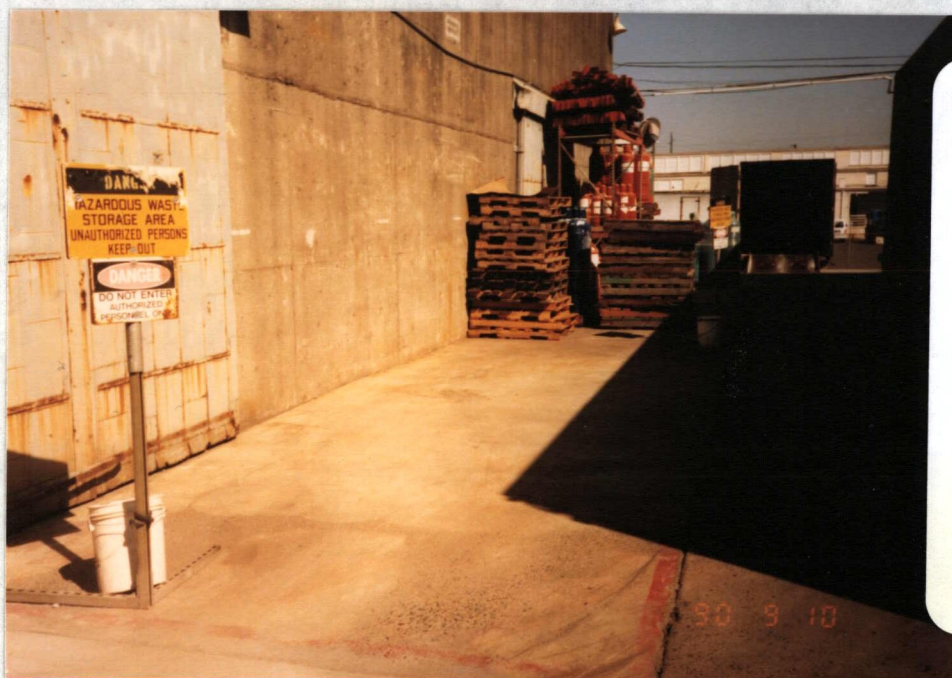
Photograph #6:

Observation of "90 day" generator storage area. On 9/10/90, date of inspection, no waste was found to be placed in storage.

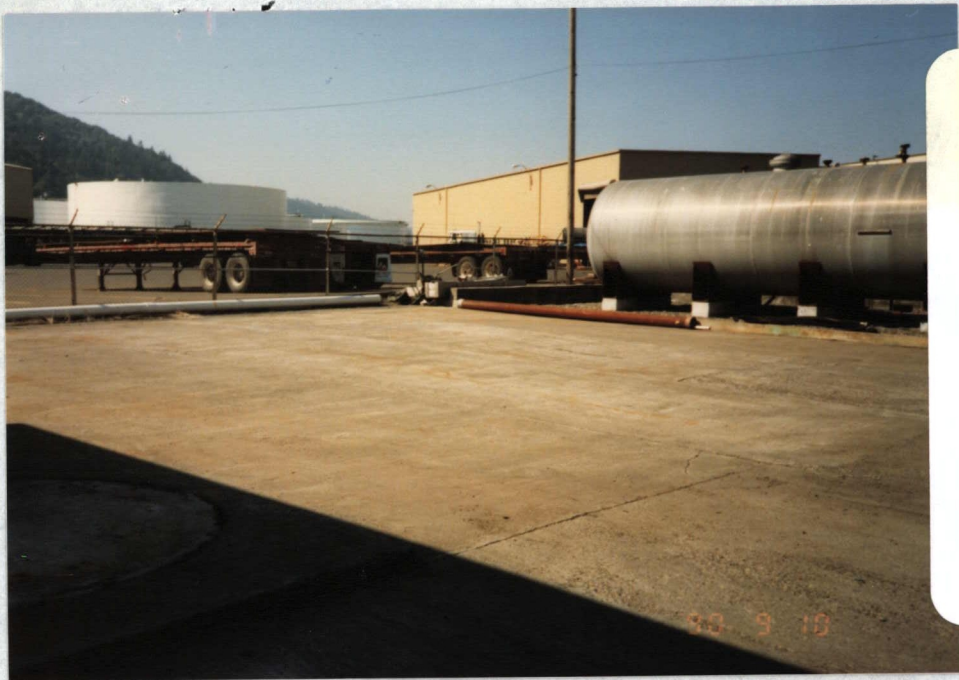
Photograph #7:

I was told that four tanks (two on either side of the building with the still in it) had been removed. I was told the tanks had contained perchloroethylene, TCA, TCE, and methylene chloride. I noticed several minor cracks in the concrete pad.

Observation of TSD storage pad located west of building and north of still. (Still is no longer operational.)

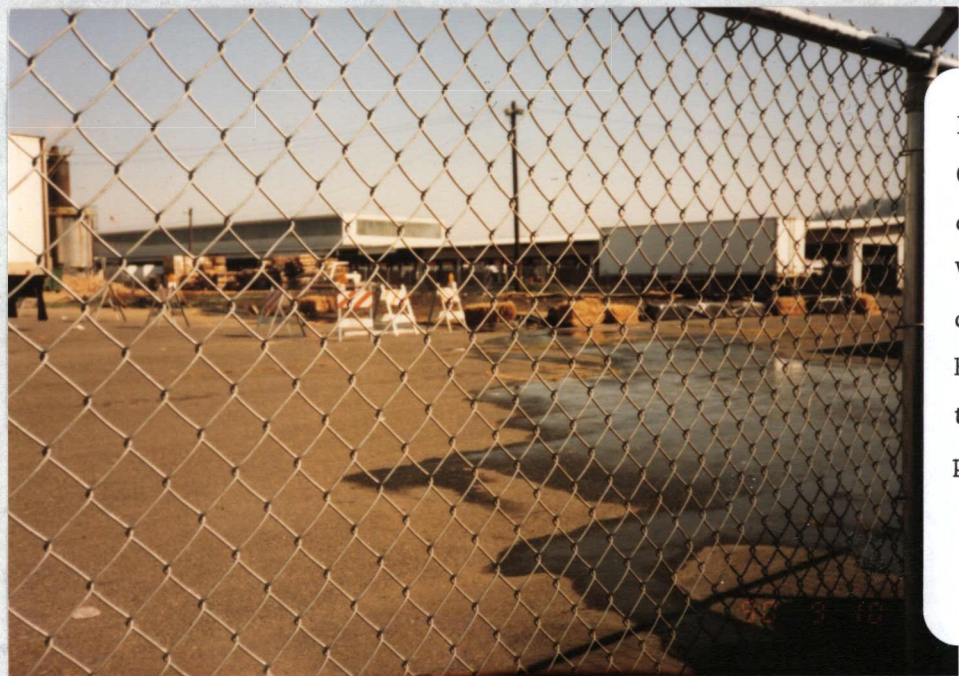
Photograph #8:

I also observed the Convoy property which borders the southeastern portion of VWR. I saw a rectangular area of dirt on the Convoy property. George Sylvester told me Convoy is landfarming contaminated soil. Two sprinklers were wetting down the soil. Water was running off the soil and draining along the asphalt, under the chain link fence and onto VWR property and into a drain next to the fence on the VWR side (see photographs 8 and 9, Appendix 7). George Sylvester told me the drain is a storm drain.

Observation of soil venting operation on property east of Van Water & Rogers. Water run-off drains on to Van Water and Rogers' property. Soils contaminated with solvents and petroleum fuel products.

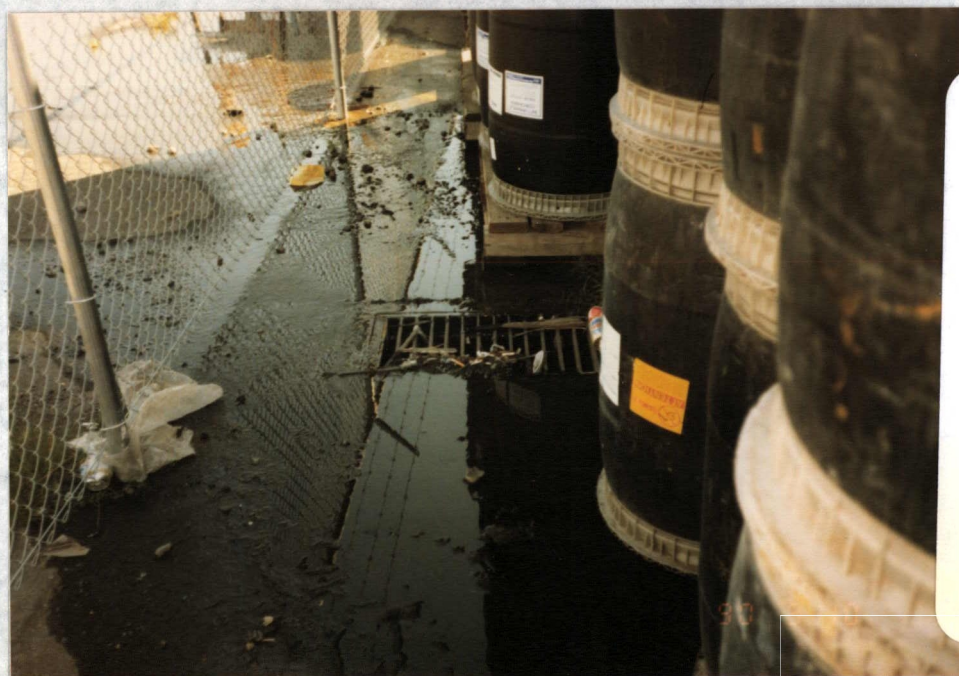
Photograph #9:

Observation of storm drain on Van Water & Rogers' property collecting run-off from off-site (see photograph #8).
